# Columbia Riverkeeper Public Comment Guide

By Simone Anter, Staff Attorney  
April 11, 2020

# Location of Structures Energy Proposes to Grout

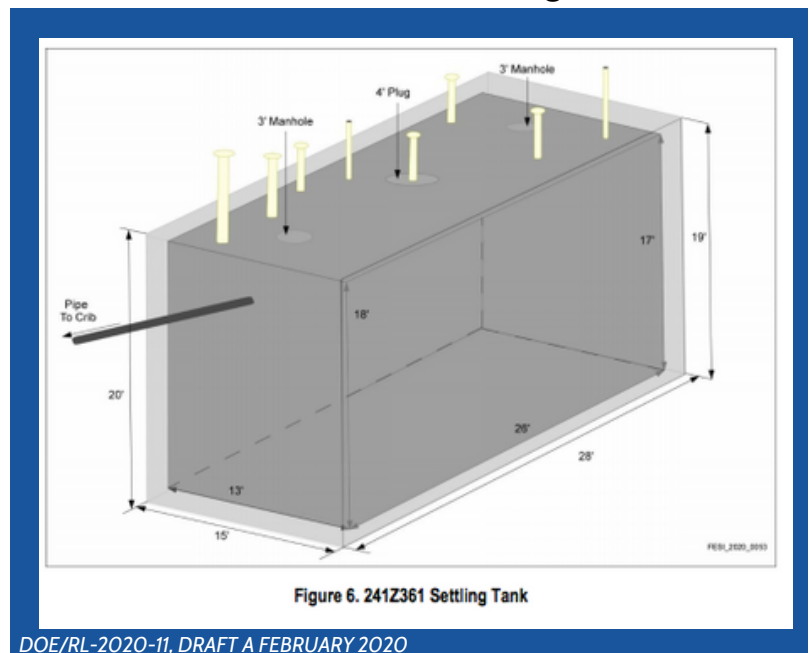
Size: 28ftL x 15ftW x 19ftH. Reinforced concrete structure with a 3/8-inch-thick steel liner.<sup>3</sup>

Overview: The Settling Tank handled all neutralized, low-salt, aqueous waste from the Plutonium Finishing Plant (PFP). Pumping out liquid waste from the Tank in 1975 left behind an 8 foot thick sludge with an estimated 26-75kg of plutonium. Structural review of the Tank was based on a 1999 video and found:

- Cracking on the Tank's interior roof;
- Etching of the cement paste off the roof slab; and
- The inner steel plate liner was dissolved or removed over most of the tank area and exposed to the tank contents.<sup>7</sup>

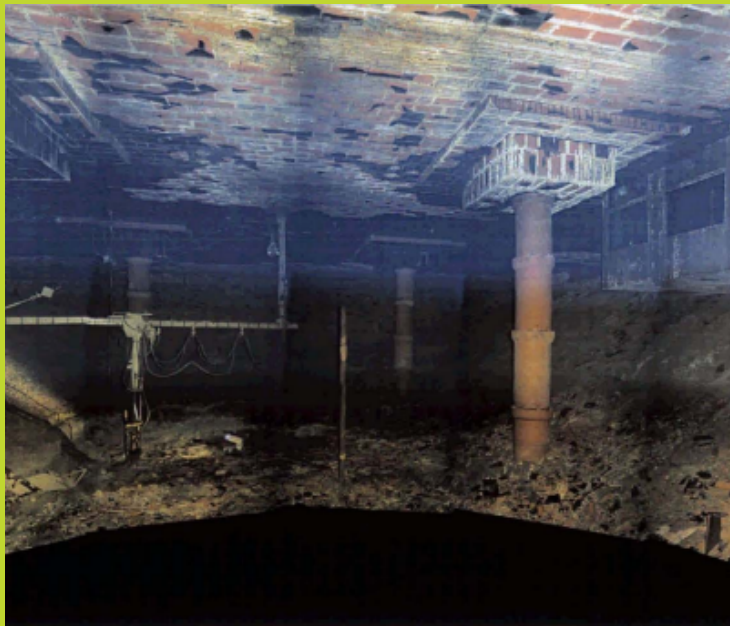
Figure 5-4. Interior of 216-Z-9 Crib.

Visual inspection revealed:

- Clay tiles on supports holding up the roof have fallen;
- Acid-resistant bricks on the roof have fallen; and
- Other roof degradation.<sup>16</sup>

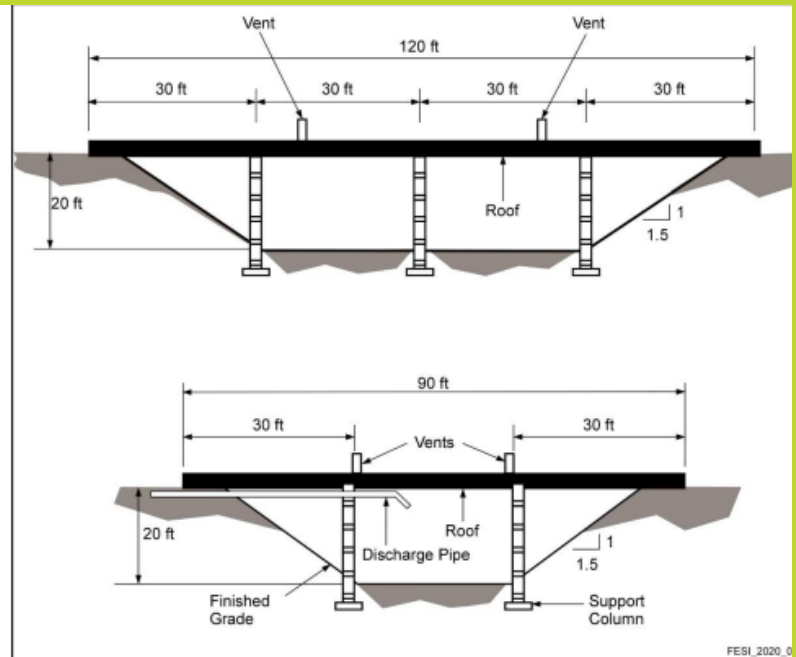
Figure 4. 216Z9 Trench

Size: 120ftL x 90ftW x 20ftH, with a concrete cover supported by six concrete columns.<sup>11</sup>

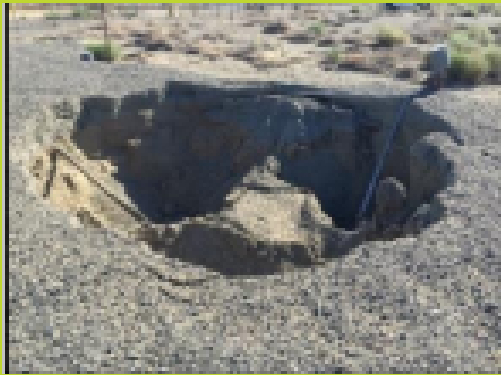
**Size:** 12ftW x 12ftW x 14ftH; a 12-foot-square, 14-foot-tall open-bottom wooden box was installed within the excavation for support.<sup>19</sup>
