Nelson County Report

Prepared by Blackburn Consulting Services, LLC

Reference: Report Analysis and Field Verification of Soil and Geologic Concerns with the Atlantic Coast Pipeline (ACP) in Nelson County, VA

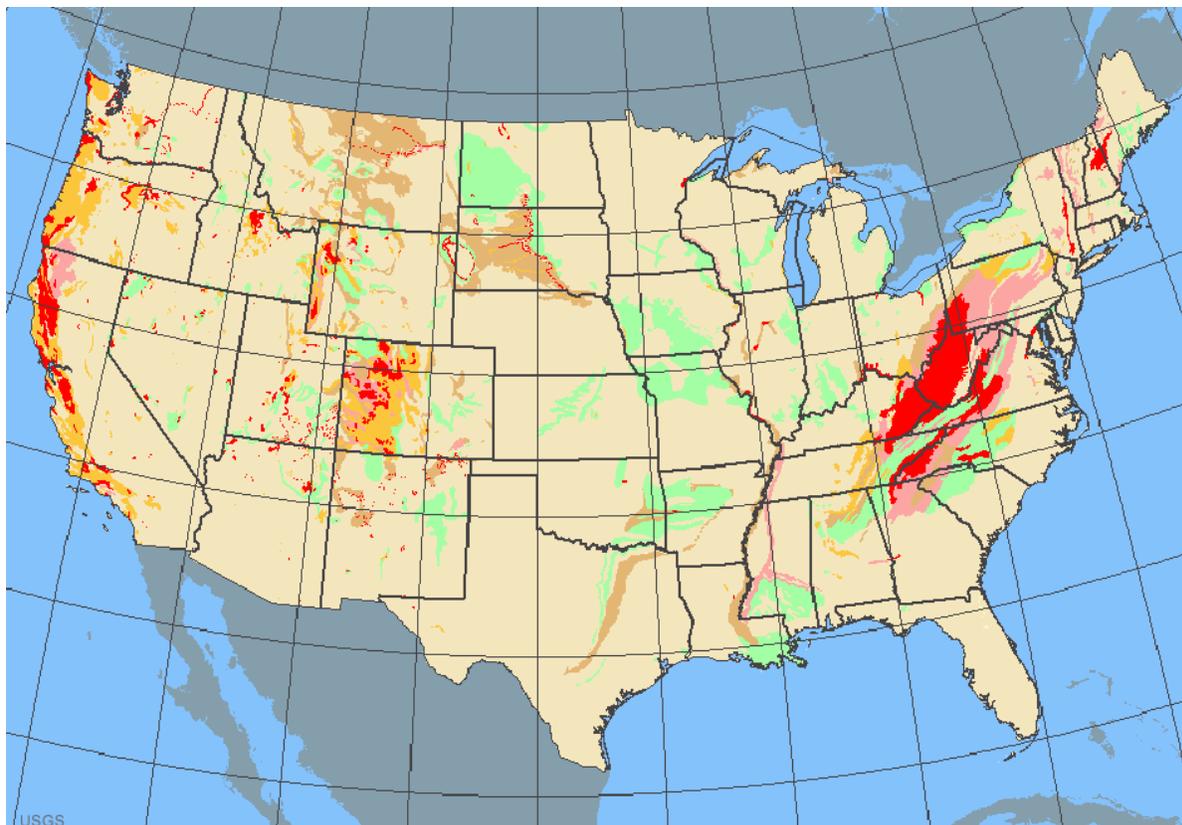
Figure 1 Landslide Incidence and Susceptibility Map of the Conterminous United States¹

This map (Figure 1) developed by the USGS, identifies the locations of, and susceptibility to, landslides.

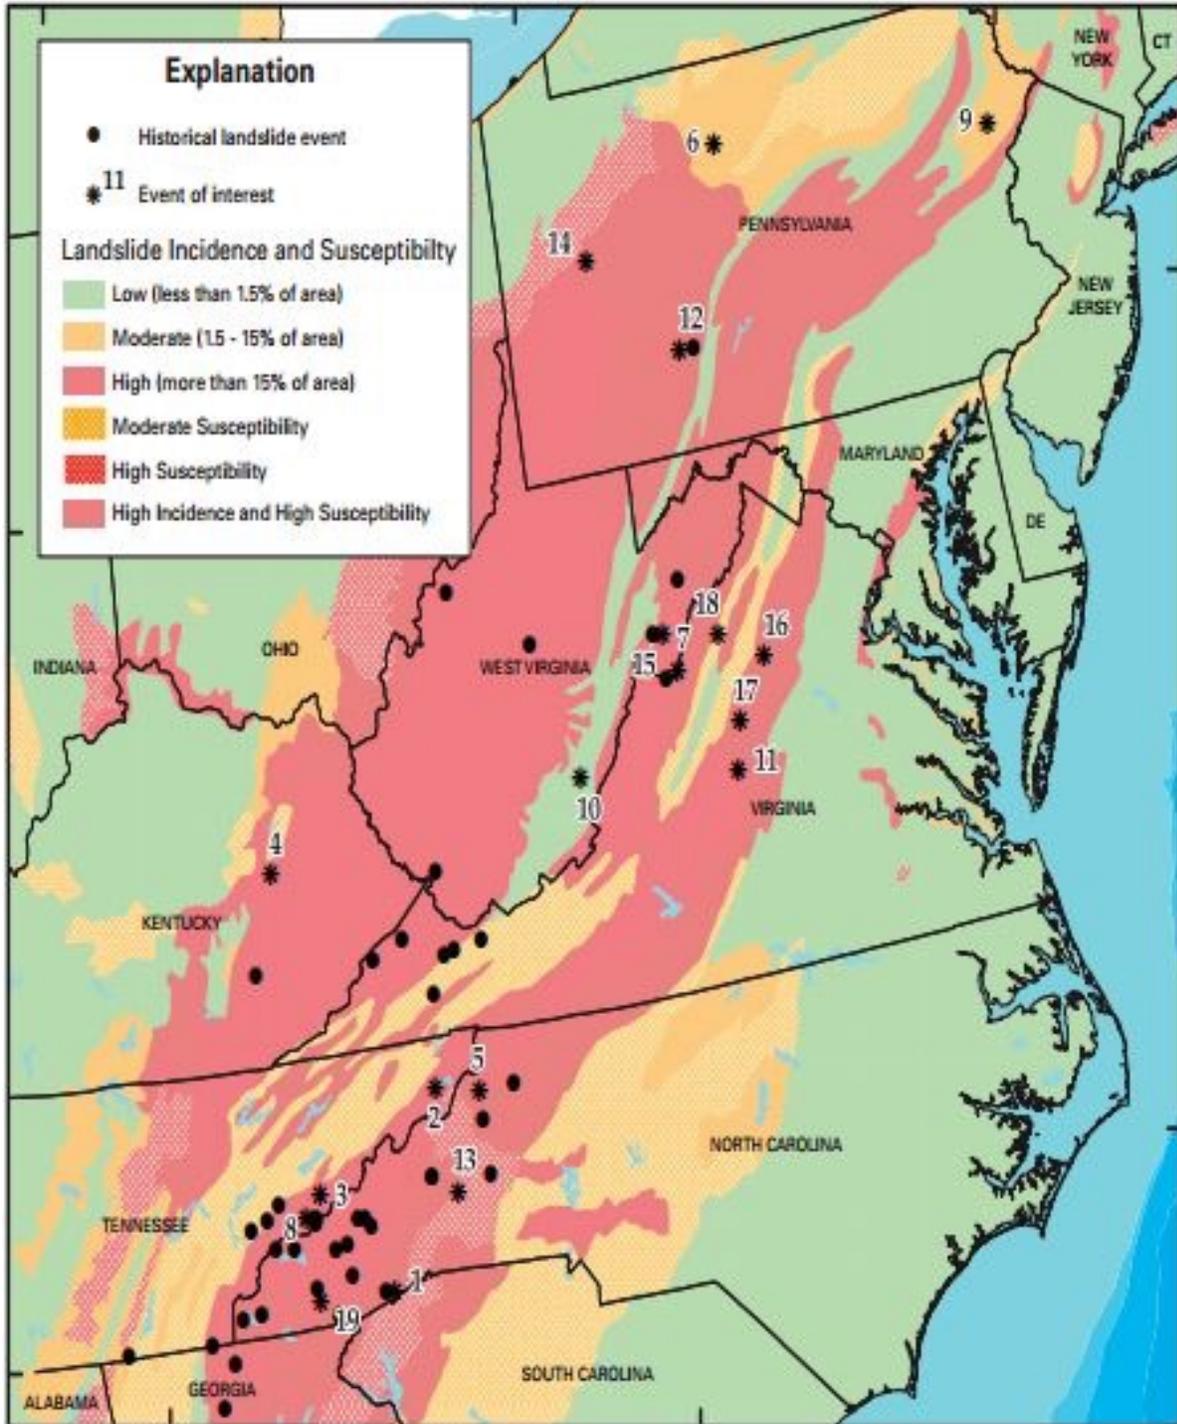
Figure 2 Historical Landslide Events Virginia¹¹

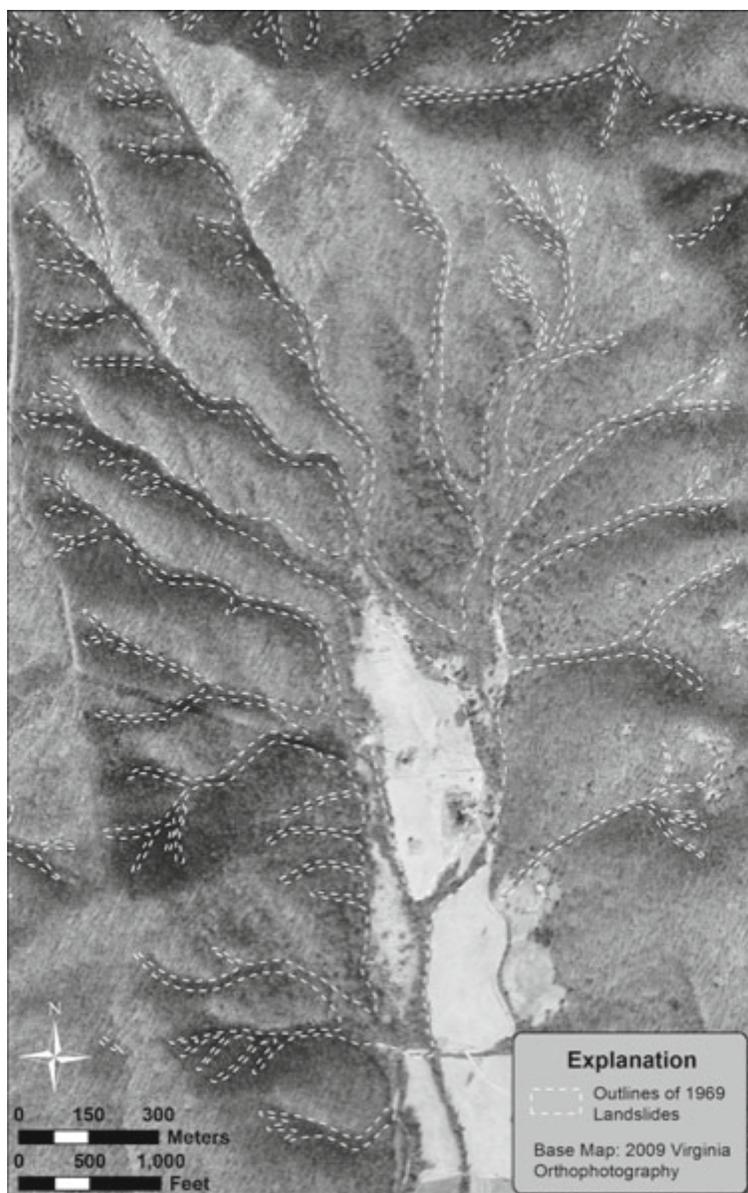
Figure 3 Outlines of 1969 landslides in Fortunes Cove area of Nelson County illustrate typical debris flow “sources” or origination points.⁹

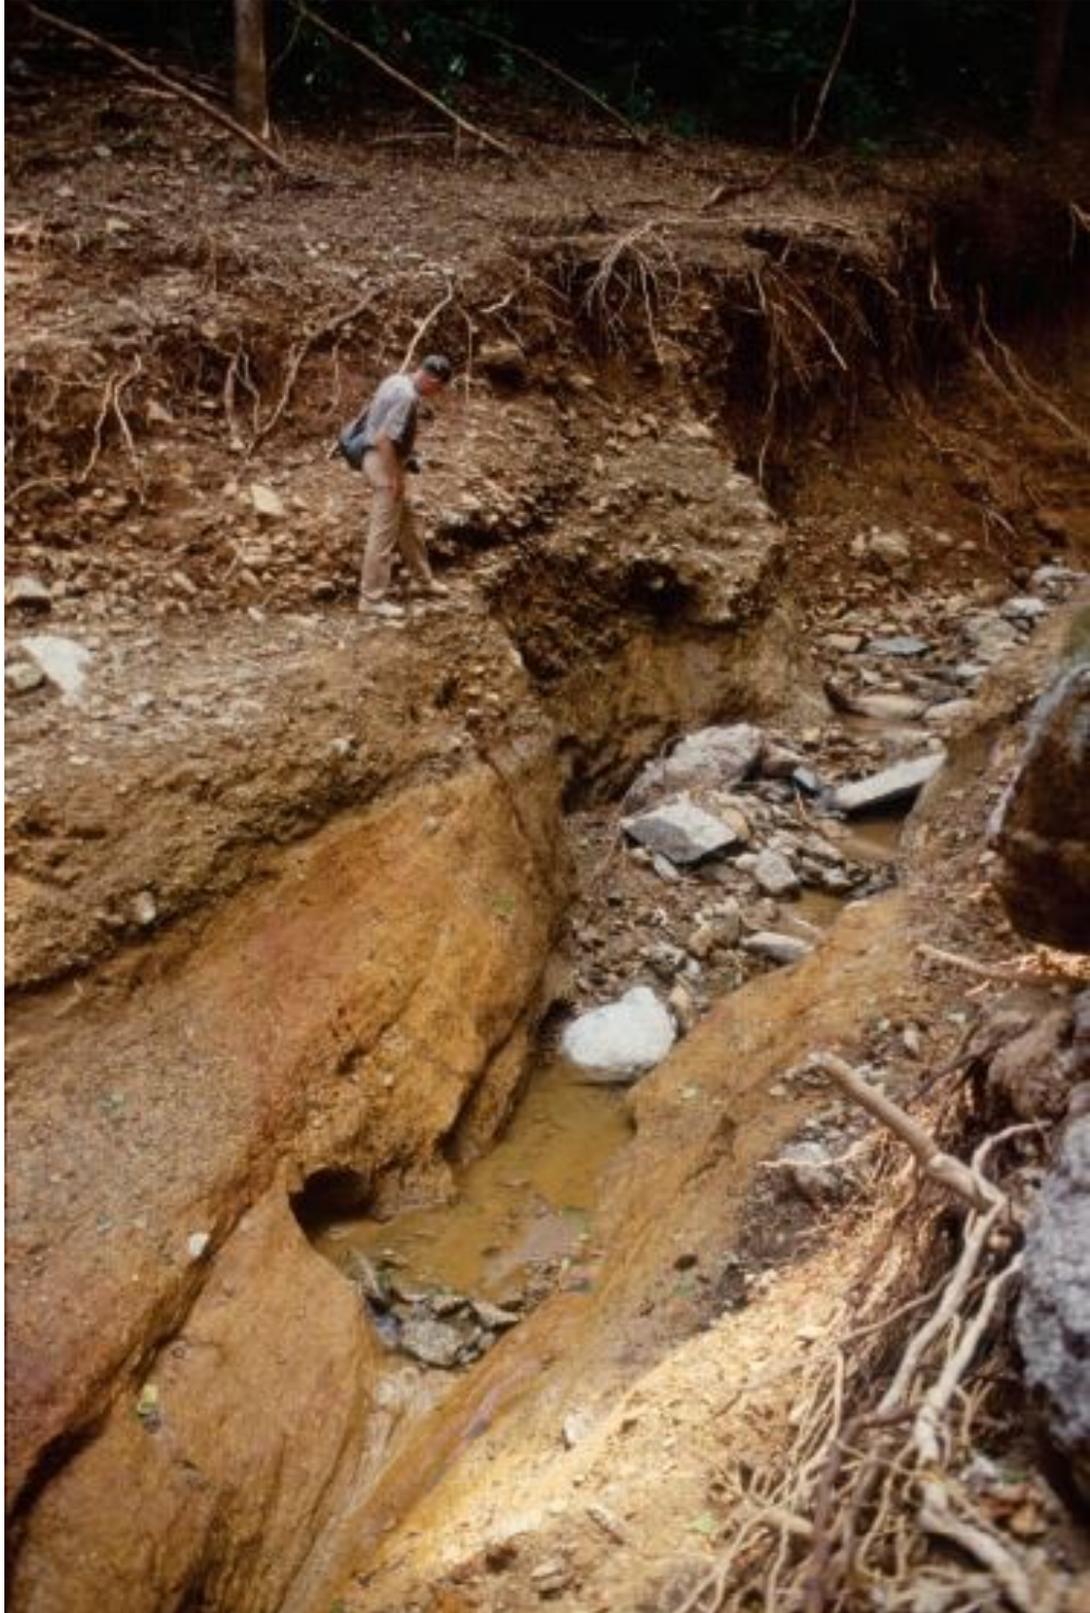
Figure 5 Scour from June 27, 1995, debris flow in Madison County, Va., revealing older debris-flow deposits¹¹.

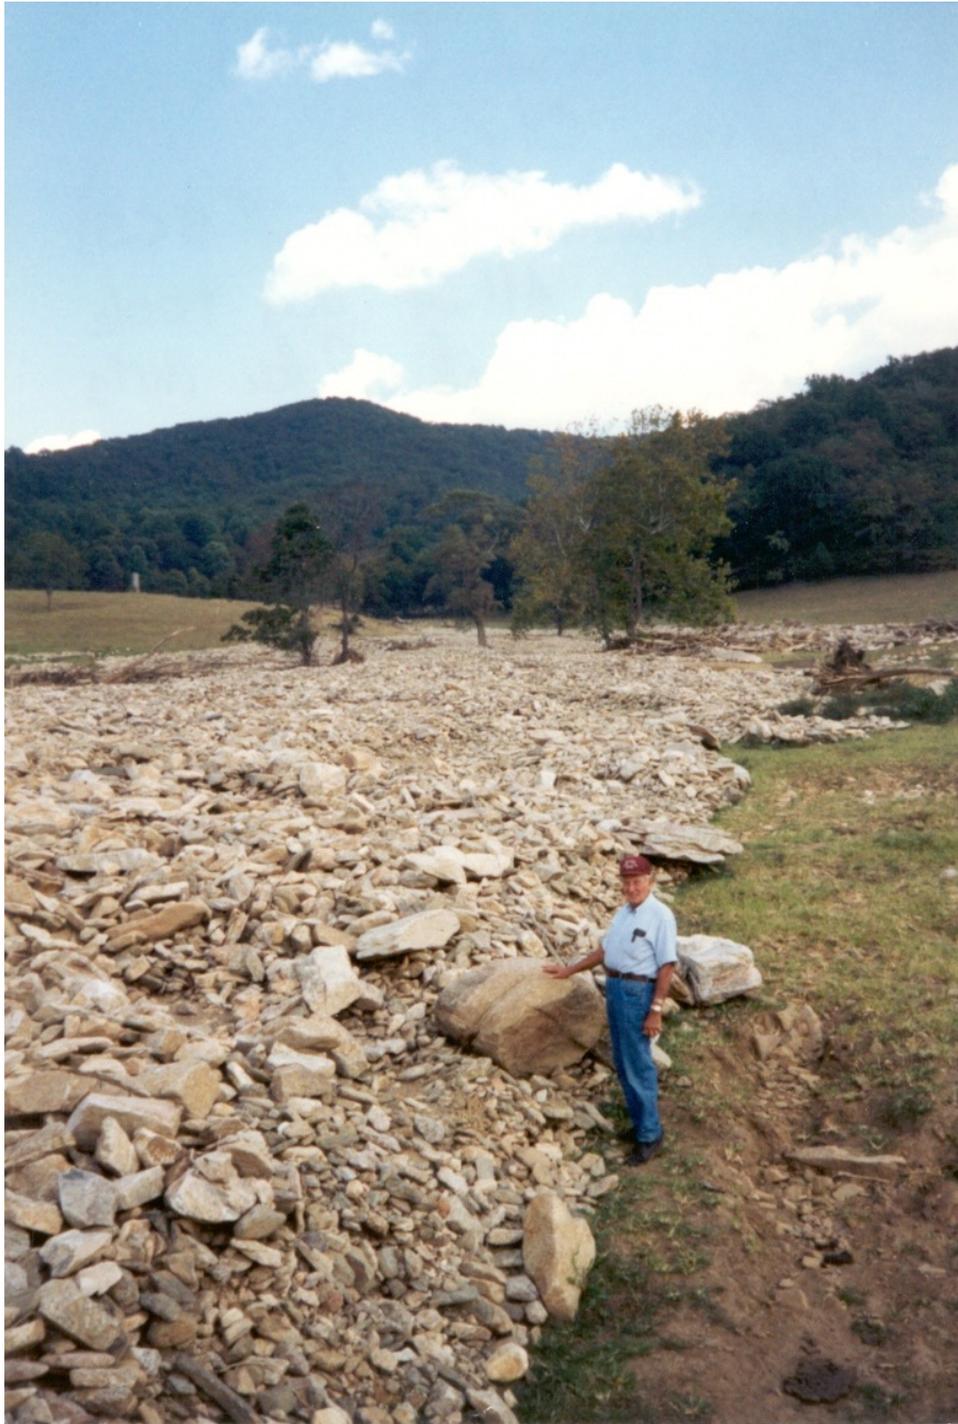
Figure 6 Example of a depositional fan in Madison County, VA investigated by Alex Blackburn.

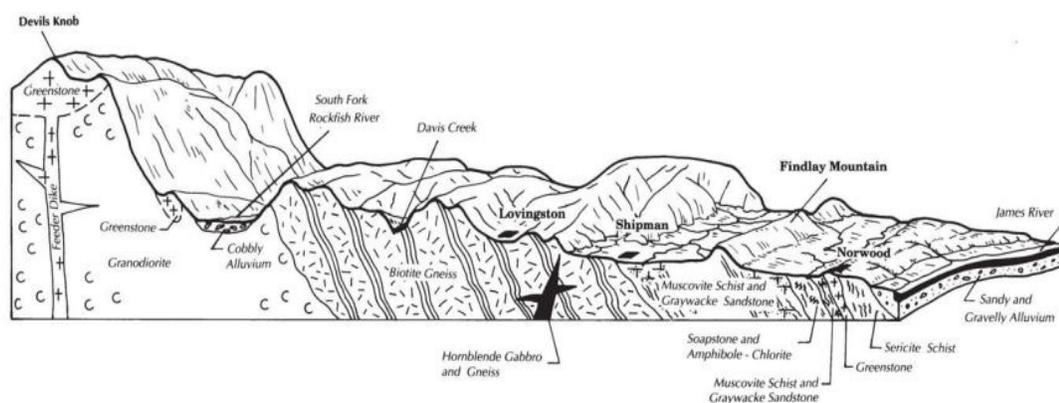
Figure 7 Soil Survey Staff (1992).

Figure 11.—Cross section of the typical landforms and rock patterns in Nelson County.

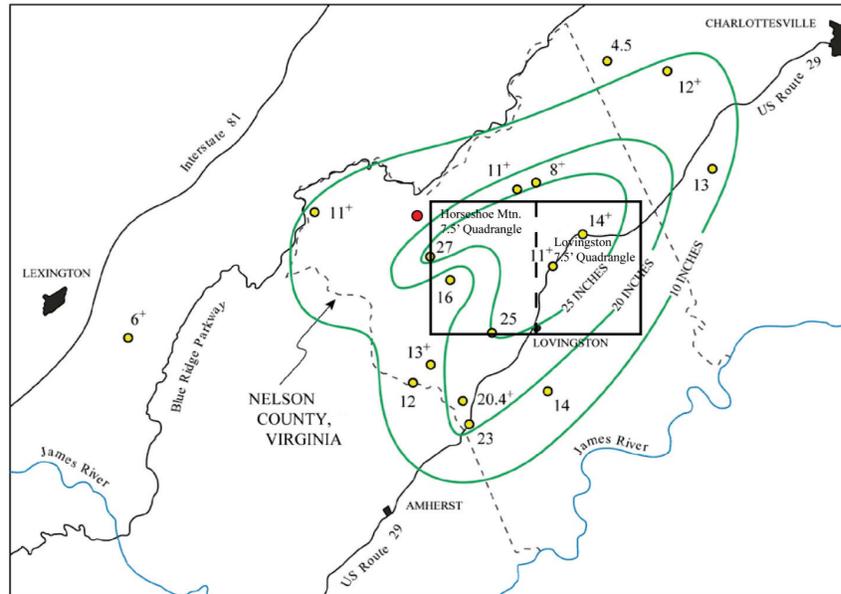
Figure 8 Representation of the most intense areas of rainfall in the Central Appalachians during Hurricane Camille¹¹

Fractured bedrock above hard slightly fractured or non-fractured bedrock compounds this phenomenon by holding the water up above it while also forming a natural surface on which the movement of the supersaturated soil material can occur. Generally, all that may be required is a catalyst such as a large tree that tumbles over when the soil is wet to initiate a sluff or debris flow. The intense weather event in 1969 as a result of Hurricane Camille created a super-saturating environment, which resulted in the multiple catastrophic debris-flows (Figure 8).

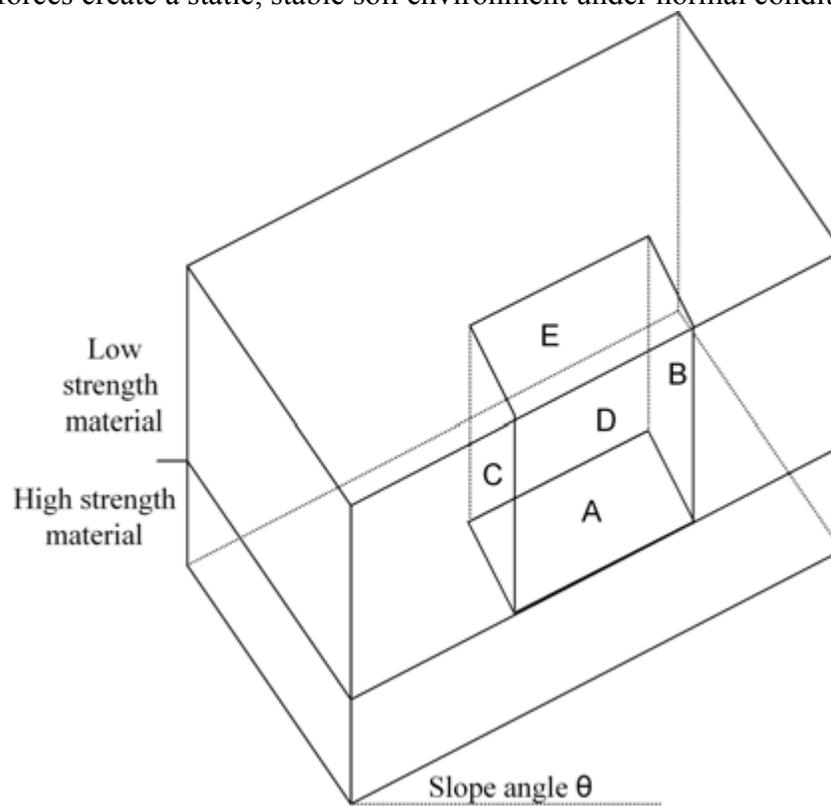
Figure 9 Three-dimensional force balance stability analysis of a soil element on a slope.⁷

“Force A on the element bottom boundary results primarily from the lithostatic stress of the element mass. Forces B and C arise from active and passive earth pressure, respectively, while forces D and E result from at rest earth pressure on the element lateral margins. At shallow soil depths, root cohesion through the base creates a high FS.”⁷

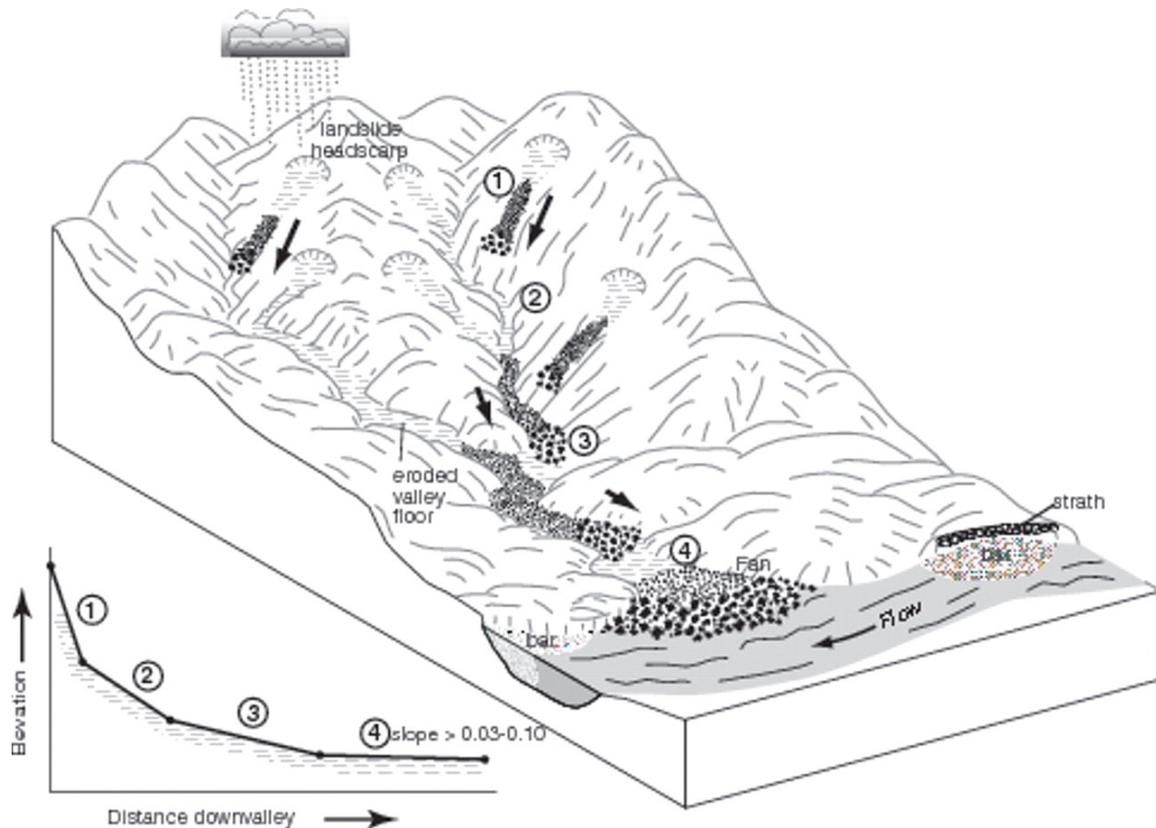
Figure 10 Illustration of debris-flow patterns and processes influenced by rainfall.¹⁴

Concave areas and colluvial soils in the steep mountainsides, by nature, have significant amounts of laterally moving water flowing through them during wet periods and storms. The installation of this pipeline will then act as an additional path for water to get into the soil. Increasing water content, particularly at the top of the mountain where many of the debris flows are known to initiate, will tend to increase rather than decrease the potential for slope failure. (See Figure 10)

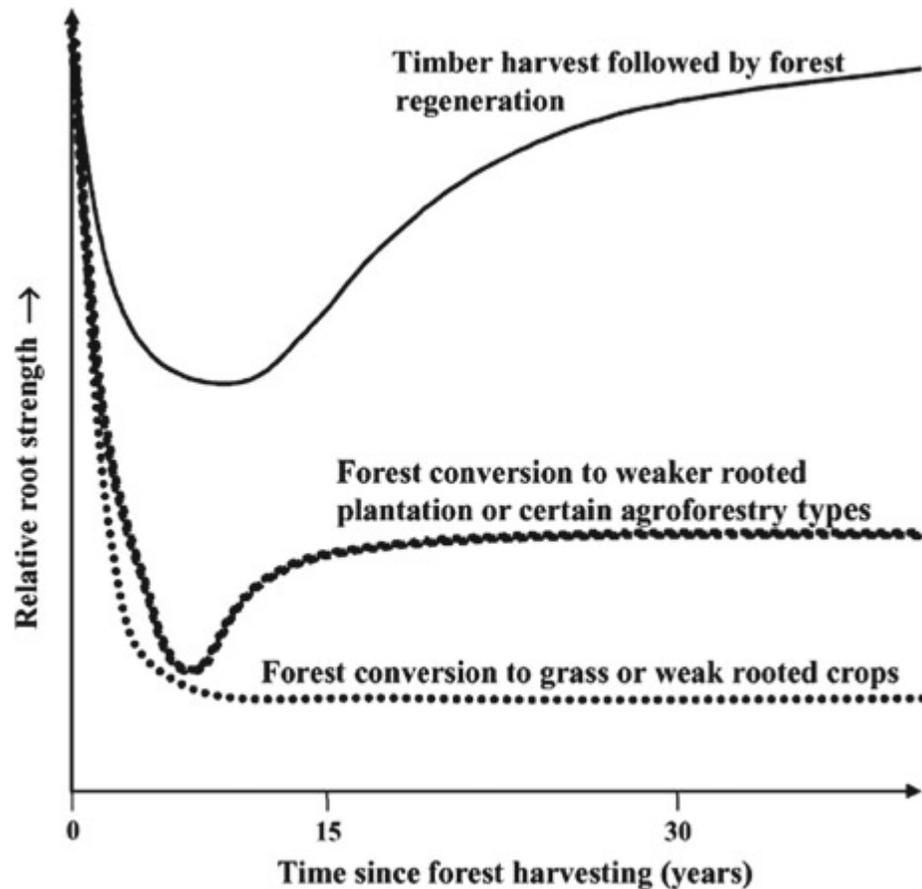
Figure 11 Root strength recovery or different cover vegetation following forest clearing.⁹

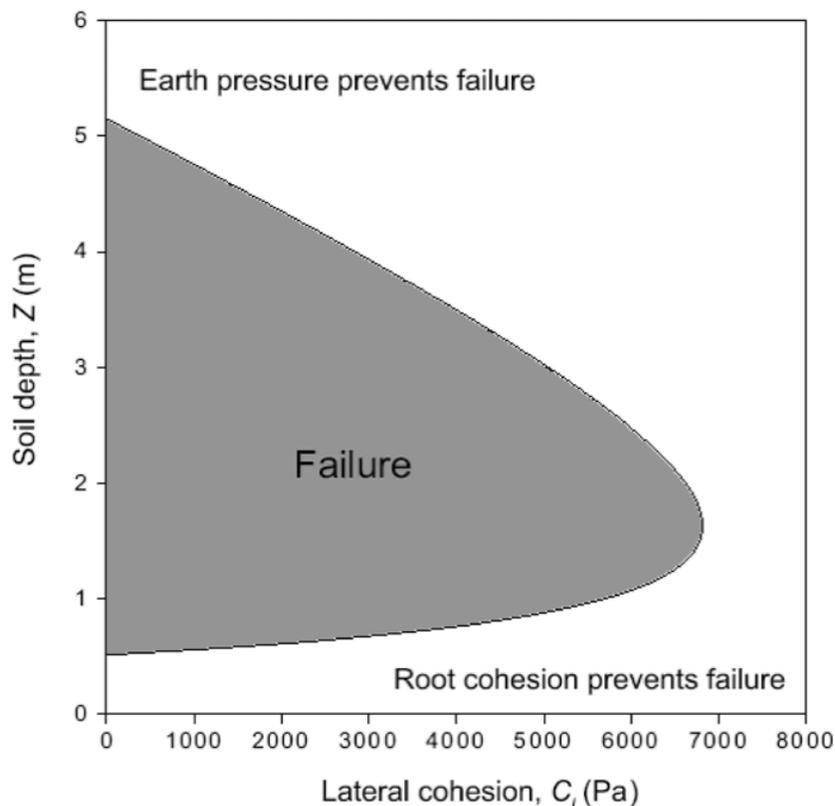
Figure 12 Relationship of soil depth, cohesion and the influence of roots.⁷

influential.¹⁵ Therefore, these forces and stability suggest that when cutting and clearing of the tree cover occurs, “instability spreads to a progressively wider range of soil thickness as lateral root strength decays”⁷. See Figure 12.

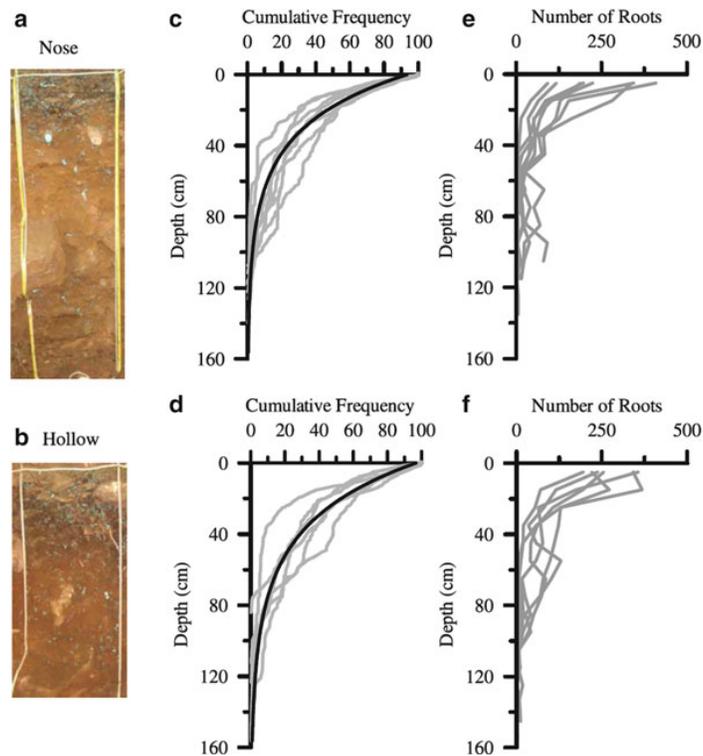
Figure 13 Root frequency and distribution within soil profile in two different landscape positions⁵

This concept was further realized during our field visit in December of 2016. Each concave landscape position that was investigated was verified to be colluvial soil, and each had a restrictive horizon in which the non-cohesive soils in place above such horizons would be increasingly susceptible to over-saturation and failure by virtue of mass-wasting. Restrictive horizons observed were bedrock, lithologic discontinuity, massive saprolite and fragipans. The stability of several of the sites investigated was also dependent on the deep tree roots, existing cover vegetation and leaf litter debris. The deep root phenomena observed supports the findings discussed as “ecohydrological controls” in *Frequency and magnitude of selected historical landslide events in the southern Appalachian Highlands of North Carolina and Virginia: Relationships to rainfall, geological and ecohydrological controls, and effects*⁵ where soils in hollows (colluvial landscapes) were found to have a larger amount of roots at depths greater than 50cm (~20”) than those soils in residual landscape positions (Figure 13.).

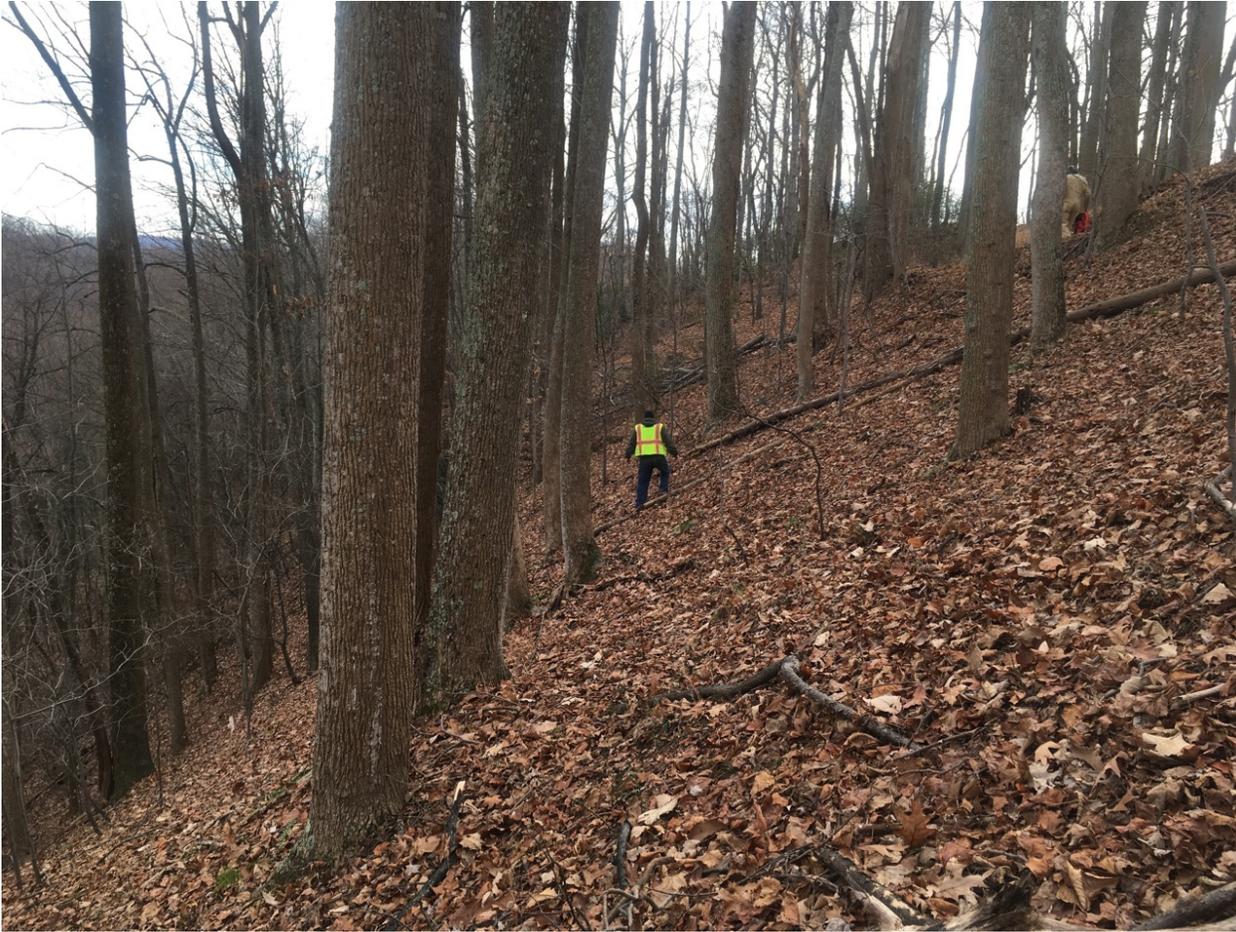
Erosion potential on these slopes and soils will be high. Based on the site work that we performed in the steeply sloping gneiss and granodiorite areas, these soils dominantly have sandy loam or coarse sandy loam surface and saprolite textures while the subsoil is dominantly loam. **These textures in combination with the very steep slopes (some we measured at 83%) increase susceptibility for failure. See Figure 14.**

Figure 14 Steep slopes observed along pipeline path during field reconnaissance.

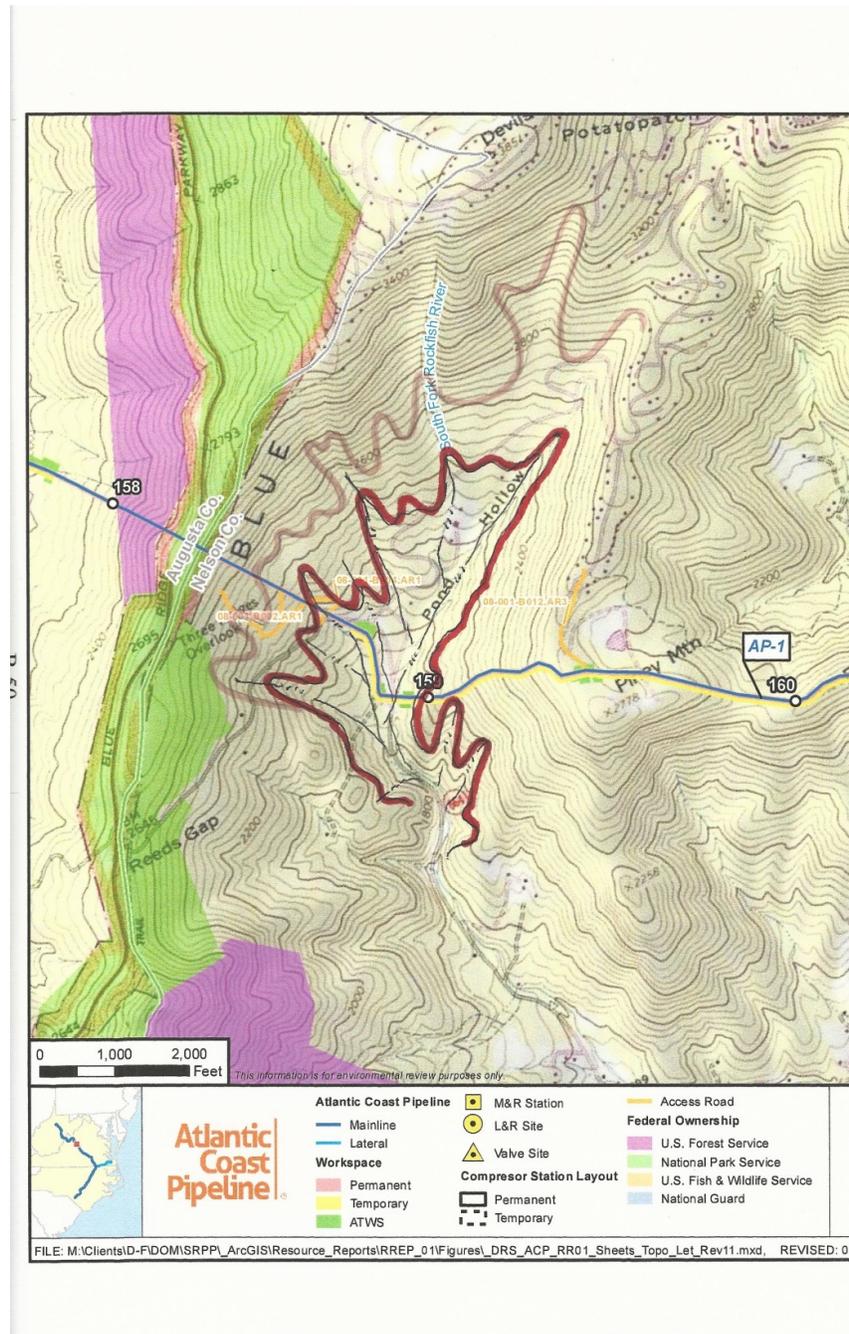
Erosion control and water quality protection in this area, as in other areas with similar boulder debris flows, will be difficult to achieve. Tremendous void space is present in these boulder fields where water flows freely although not visible on top of the ground. Therefore, due to the nature of these old debris flows, there may be little surficial evidence of erosion and sediment being carried by water. However, it is our experience

that a high volume of water flows through these areas during many portions of the year and the sediment may not show up in the surface water until much further down in the stream.

Figure 15 Illustration developed by Blackburn Consulting Services, LLC

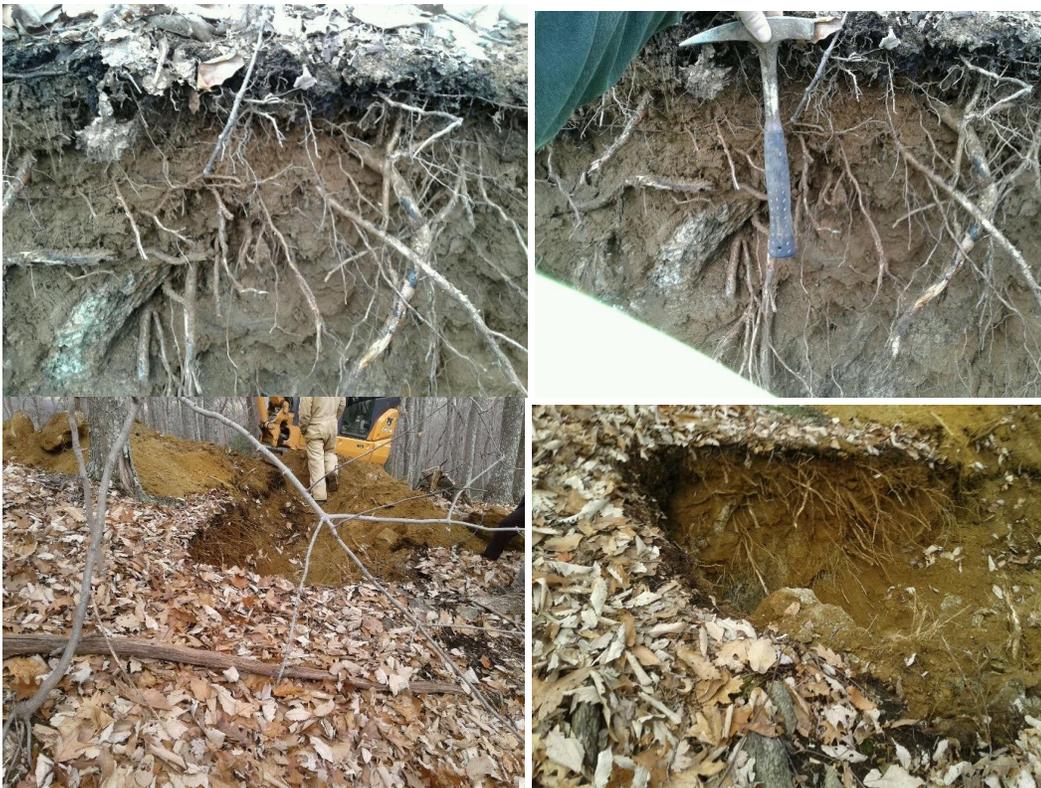
Hole #	Horizon	Depth	Description of color texture, etc.	Texture Group
Pit #1 Site 1	A	0-9	Black (10YR 2/1) loam, moderate medium granular structure; friable, non-sticky, non-plastic; many fine, medium & coarse roots; 10% granite gneiss / grandiorite rock fragments	II
	Bt	9-26	Strong Brown (7.5YR5/6) sandy loam; weak medium subangular blocky structure; very friable, non-sticky, non-plastic; common fine & medium roots; 20% granite gneiss / grandiorite rock fragments	II
	C	26-48	Yellowish brown (10YR5/6) and strong brown (7.5YR5/6) sandy loam highly variable parent material with common white, black, strong brown, light grayish brown lithochromic features; massive parting to loose structure; slightly firm, non-sticky, non-plastic; few fine & medium roots; 20% highly fractured, granite gneiss / grandiorite rock fragments	II
	R	48+	Weather rhyolite grandiorite and gneiss rock

Northeast aspect, with sideslopes at 66% adjacent to pit. Landscape slope 34%. Pinnacles of bedrock within 36"

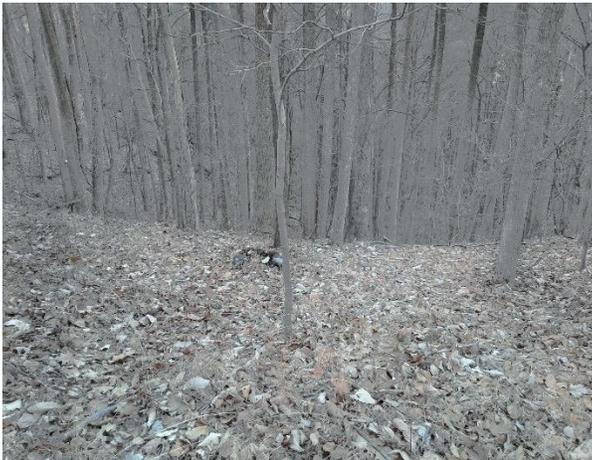
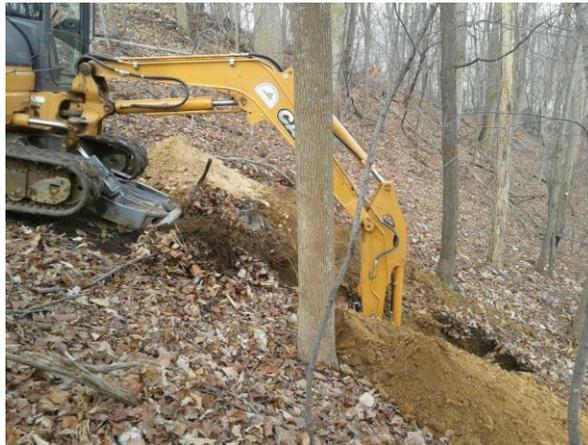
Pit #2 Site 1	A	0-7	Black (10YR 2/1) loam, moderate medium granular structure; friable, non-sticky, non-plastic; many fine, medium & coarse roots; 10% granite gneiss / grandiorite rock fragments	II
	Bt	7-24	Strong brown (7.5YR4/6) sandy clay loam; weak fine subangular blocky structure; very friable, slightly-sticky, non-plastic; many fine & medium roots; 10% granite gneiss / grandiorite rock fragments	II
	Ab	24-34	Dark yellowish brown (10YR4/6) sandy loam; weak fine subangular blocky structure; friable, non-sticky, non-plastic; common fine & medium roots; 10% granite gneiss / grandiorite rock fragments	II
	Cx	34-50	Reddish yellow (7.5YR6/6) loamy sand, weak, fine platy structure parting to loose structure, very firm in place, 70% brittleness, non-sticky, non-plastic	I
	2C	50-62	Brownish yellow (10YR6/6) and reddish yellow (7.5YR6/6) highly variable sandy loam with common white, black, strong brown, light grayish brown lithochromic features; massive parting to loose structure, friable, non-sticky, non-plastic, 20% granite gneiss / grandiorite rock fragments	II

Top of large, concave side slope. At top of landscape, slope is 50% with a northwest landscape. Slope measurements below pit elevation within the concave side slope were at or exceeding 82%.

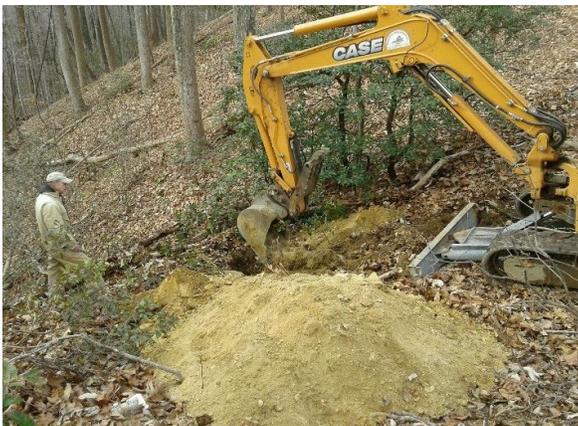
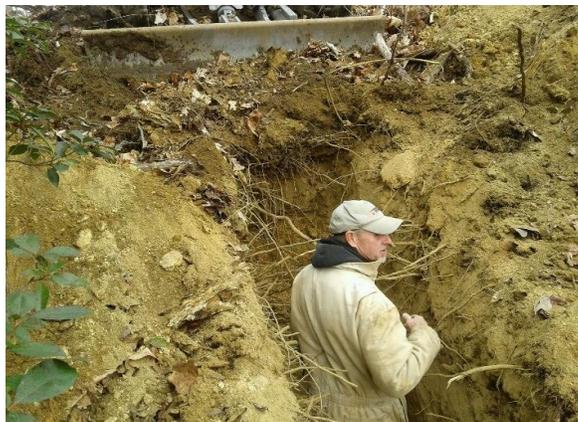
Head of small, ephemeral drain, limited concave landscape. Evidence at lower elevation of past debris flow. At top of landscape, slope is 46% with a southeast aspect.

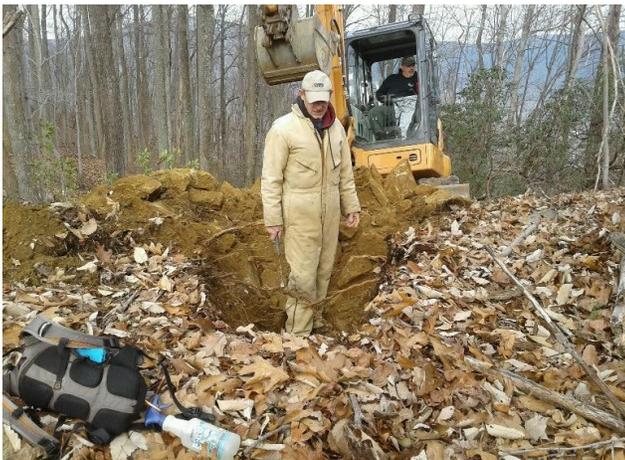
Pit #4 Site 1	A	0-5	Black (10YR 2/1) loam, moderate medium granular structure; friable, non-sticky, non-plastic; many fine, medium & coarse roots; 10% granite gneiss / grandiorite rock fragments	II
	C	5-30	Brownish yellow (10YR6/6) loamy sand; massive, rock controlled structure; loose, non-sticky, non-plastic; many fine & medium roots; 65% granite gneiss / grandiorite rock fragments	II
	R	30+	Weather rhyolite grandiorite and gneiss rockj

On top of ridge. Varying between 30-36" to hard bedrock.

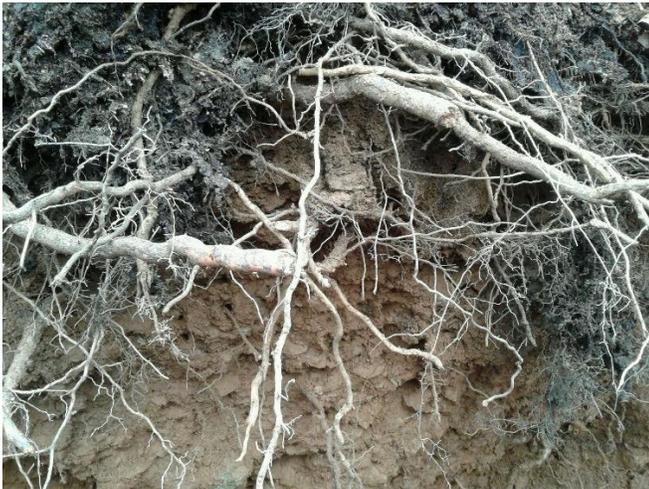
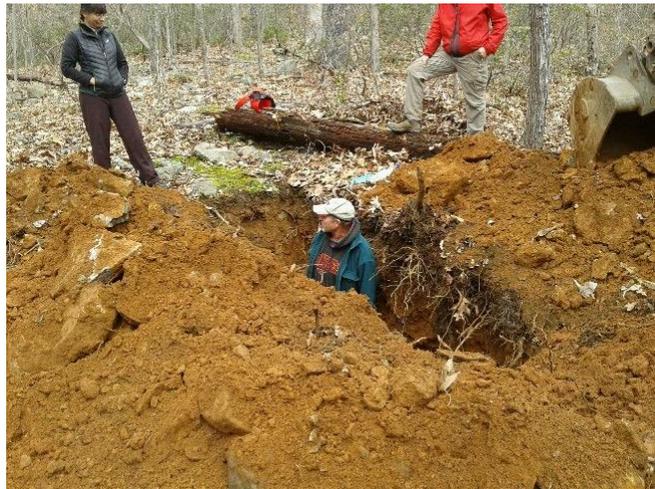
Across from Wintergreen entrance, within site / equipment area for potential HDD tunneling. Distinct debris flow area, very stoney surface.

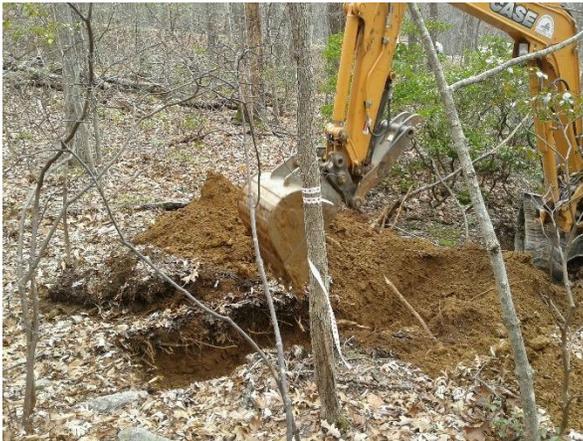
Across from Wintergreen entrance, within site / equipment area for potential HDD tunneling. Distinct debris flow area, very stoney surface, north of Pit#1 and in a different debris flow event.

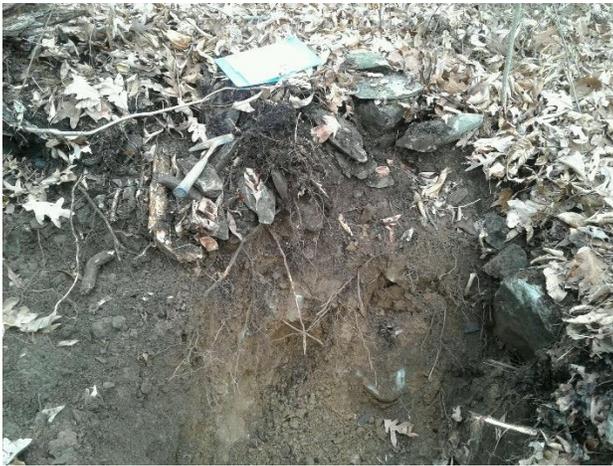
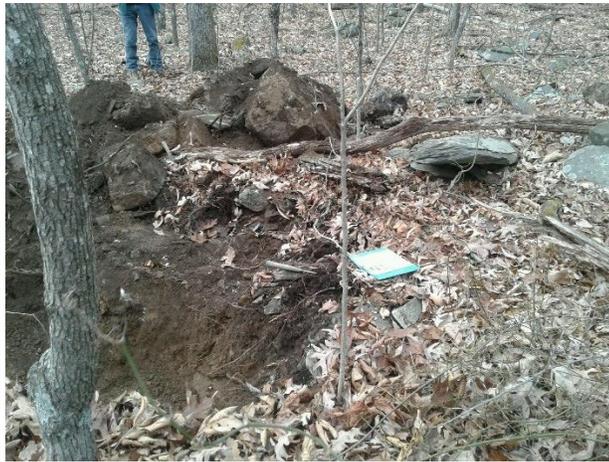
Above Wintergreen entrance, above potential HDD tunneling unless routes are changed. above debris flow area, stoney surface, some local colluvium within area, 8% slopes and just east of >50% slopes to the top of the Blue Ridge.

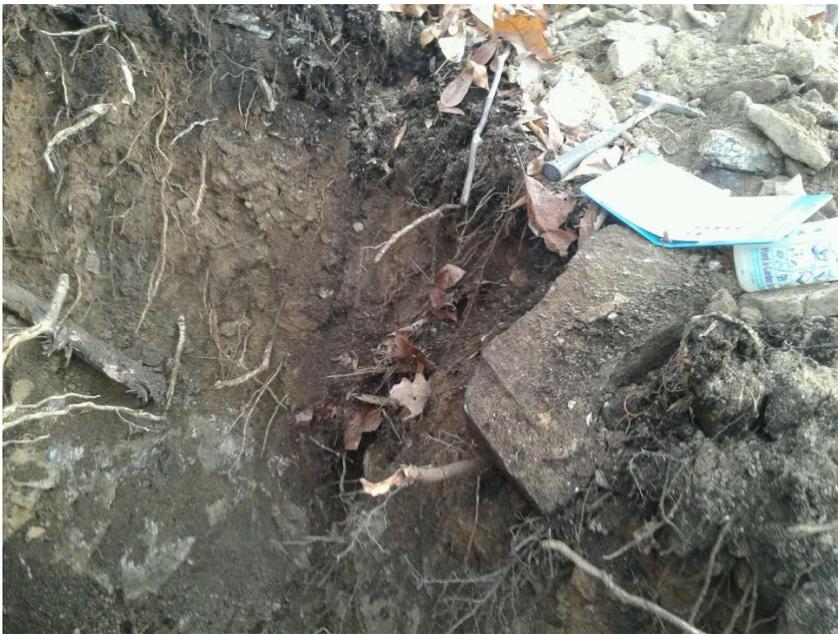
Roberts Mountain. Slopes 29% downslope from pit along spine ridge, 68% side slopes north of ridge. Pit is influenced by soil creep.

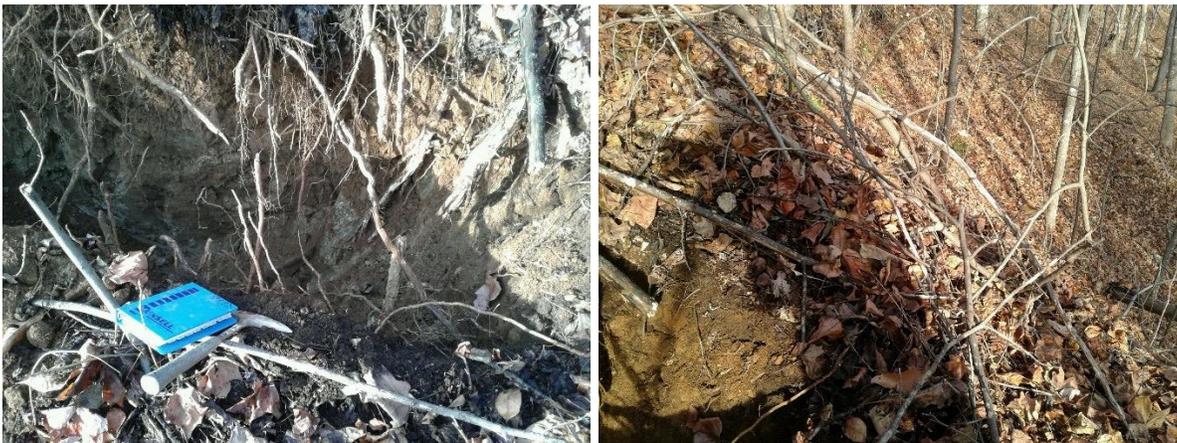
Roberts Mountain. Above Pit #1 and on the edge of a distinct debris flow, mapped from Camille event.

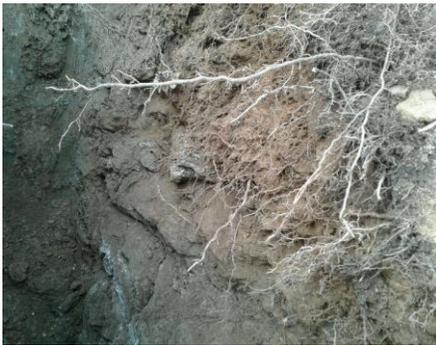
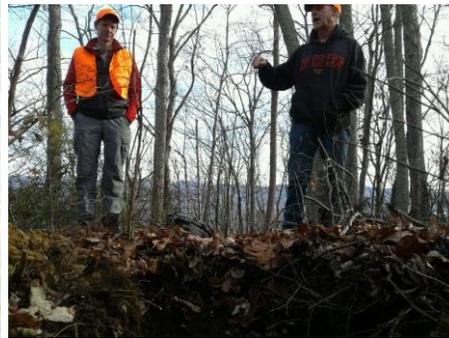
Pit #4 Site 3	A	0-11	Black (10YR 2/1) loam, moderate medium granular structure; very friable, non-sticky, non-plastic; many fine, medium & coarse roots; 30% granite gneiss / grandiorite rock fragments	II
	Bw	11-20	Yellowish brown (10YR5/6) sandy loam; loose, structureless; loose, non-sticky, non-plastic; common fine & , few medium roots; 60% granite gneiss / grandiorite rock fragments and stones	II
	Cr	20-48	Brownish yellow (10YR6/8) loamy sand; loose, massive rock controlled structure; loose, non-sticky, non-plastic; 80% highly fractured granite gneiss / grandiorite boulders	I
Depth to rock check on ridge.

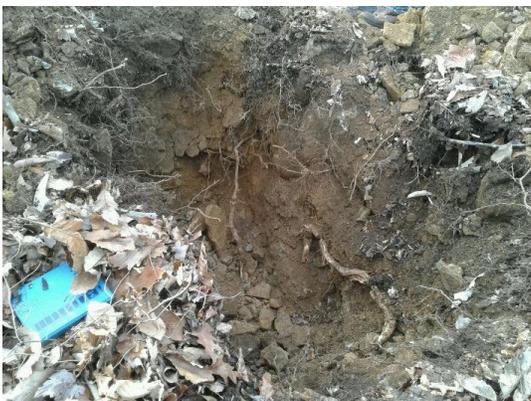
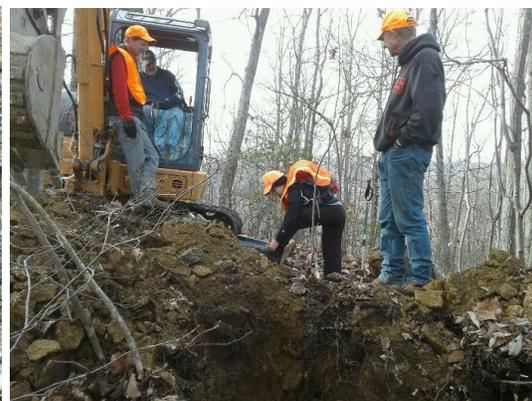
Pit #5 Site 3	A	0-6	Black (10YR 2/1) silt loam, moderate medium granular structure; very friable, non-sticky, non-plastic; many fine, medium & coarse roots; 30% granite gneiss / grandiorite rock fragments	II
	Bw	6-28	Brownish yellow (10YR6/8) sandy loam; weak, fine subangular blocky structure; very friable, non-sticky, non-plastic; many fine, medium & coarse roots; 20% granite gneiss / grandiorite rock fragments	II
	2Cr	28-39	Brownish yellow (10YR6/8) coarse sandy loam; loose, rock controlled structure; loose, non-sticky, non-plastic; common fine & medium roots, granite gneiss / grandiorite	II
	3C	39-63	Brownish yellow (10YR6/6) fine sandy loam; massive structure; loose, non-sticky, non-plastic; common fine & medium roots; highly weathered greenstone saprolite	II
Side slope at head of access road. Slope approaching ridge is 65%.

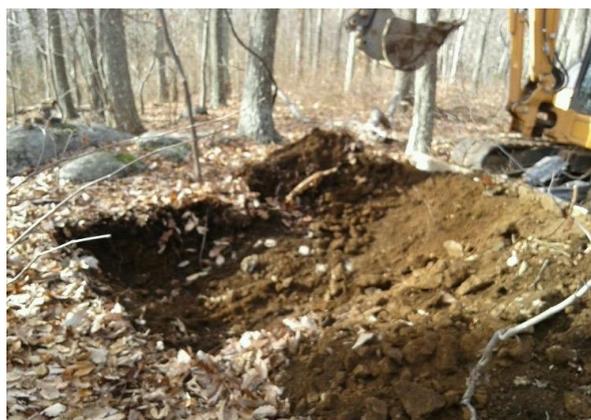
Pit #6 Site 3	A	0-5	Very dark brown (10YR 2/2) sandy loam, moderate medium granular structure; very friable, non-sticky, non-plastic; many fine, medium & coarse roots; 30% granite gneiss / grandiorite rock fragments	II
	Bw	5-24	Reddish yellow (7.5YR6/8) sandy loam; loose, structureless; very friable, non-sticky, non-plastic; common fine & , few medium roots; 55% granite gneiss / grandiorite rock fragments and stones	II
	R	24+	Hard granite gneiss / grandiorite	I
Top of the ridge.

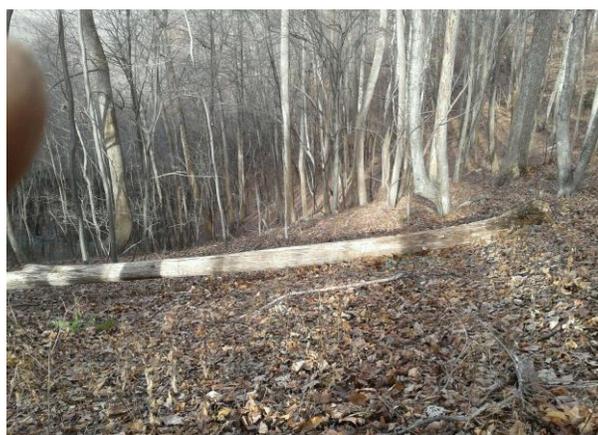
Pit #7 Site 3	A	0-4	Very dark brown (10YR 2/2) silt loam, moderate medium granular structure; very friable, non-sticky, non-plastic; many fine, medium & coarse roots; 30% granite gneiss / grandiorite rock fragments	II
	Bw	4-19	Yellowish brown (10YR5/6) weak sandy loam; weak, fine granular structure parting to structureless; loose, non-sticky, non-plastic; many fine, medium & coarse roots; 35% granite gneiss / grandiorite rock fragments and stones	II
	Cr	19-58	Highly weathered and fractured granite gneiss / grandiorite, loamy sand, common fine, medium & coarse roots	I
Head of a concave sides slope within ACP construction easement. Appears only slightly more stable than Pit #2. Slopes >60%.
